# Challenges Associated with Pipe-borne Water Infrastructure in Erelu Waterworks Zone, Oyo State, Nigeria

**Abstract-** The current study explores the infrastructural weaknesses that make Erelu waterworks zone inadequate in Oyo State, Nigeria. A mixed methods approach was adopted using GIS mapping, observation, archival research, and interviews. The Erelu Water Works is characterized by several systemic infrastructural malfunctions. The dam faces siltation through urban runoff, and residential encroachment. The treatment infrastructures are seriously out of date, with faulty aeration tank, manual lime dosing, inefficient high lift pumps, and abandoned Booster stations. The 12-inch main pipeline (6.8km) designed to transport the water to the Sooro Booster station has been punctured by many household connections to this pipe. As a result, 90.83% of the registered users in Oyo, Awe, Ilora, Akinmorin, Fiditi, and Iware towns are without water supply. The attempts by the government to rehabilitate the facility have been unsuccessful as can be seen from a ₦10 billion Fiditi Earth dam that was started in 2011 and had to be abandoned by 2020. Another attempt was made in 2019 through a ₦1.

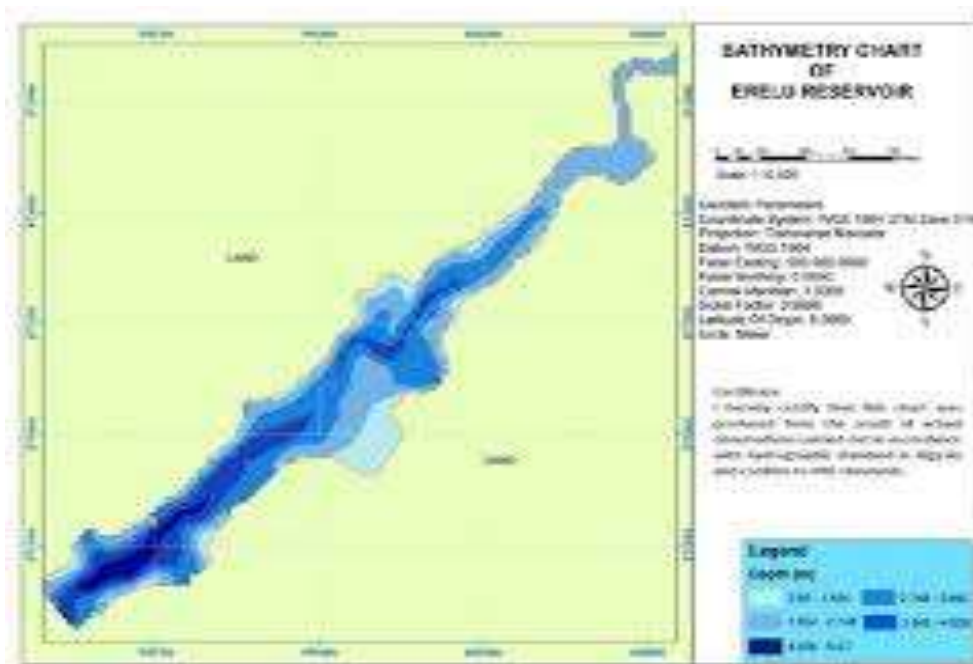
inflow point of a stream into Erelu Dam has become significantly shallow due to the accumulation of substantial debris loads transported annually by the stream.

The surface area of Erelu Dam has equally suffered an immense reduction over time; this was calculated to

be 13,106 hectares (131.06 square kilometers) by Ufoegbune and Eruola in 2011. And by 2021, Oluksunkanmi et al. carried out another study indicating that the surface area of the dam has reduced to 120.94 hectares or 1.2094 square kilometers. Furthermore, the dam's perimeter fence has been severely encroached upon, with residential developments extending to the Dam edges. This encroachment would pose a significant challenge to any prospective expansion or rehabilitation efforts.

Figure 9: Bathymetric Chart of Erelu Dam

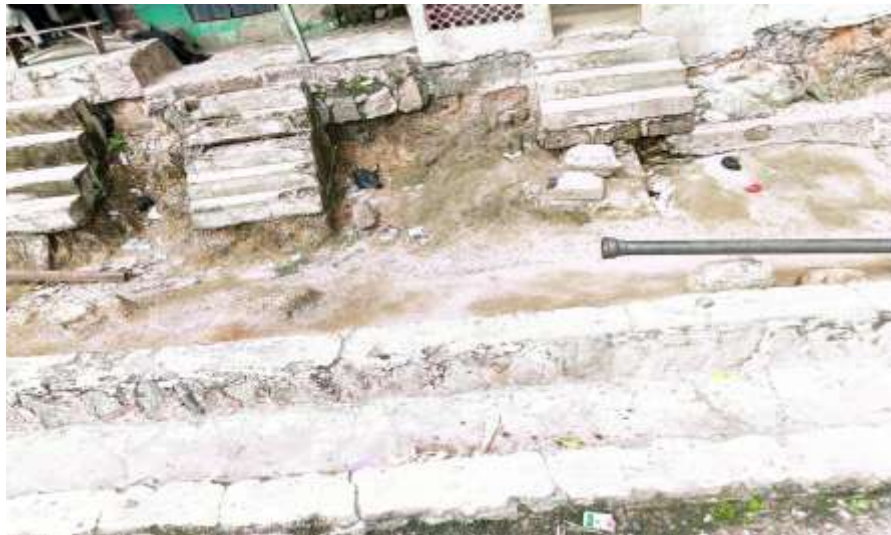
Urban construction activities have increasingly subjected water pipelines to erosion, corrosion, and physical damage. Field investigations revealed that water pipes installed in 1961 were typically buried at

an average depth of three meters below the ground surface. These pipes predate the construction of most current roadways. Over the past six decades, the development of roads, gutters, and other urban infrastructure, coupled with associated erosive forces, has exposed these water pipes to environmental stresses, resulting in significant realignment, deterioration, and breakage. This phenomenon is particularly evident in locations such as Alebiosu, Moja, Oke Loogun, Akunlemu, Oranyan, Olooro, Ilora-Akinmoorin Road, Ilora, and Fiditi (refer to Plate 2), and overall water supply reliability. The power supply to water infrastructure is unreliable, leading to frequent shutdowns and reduced water production. The power supply issue has led to residents experiencing days without water, impacting the use of water kiosks and overall water supply reliability (Oludare, 2021)

Plate 2: Water Service Pipe Exposed to Erosion, Corrosion, and Damage

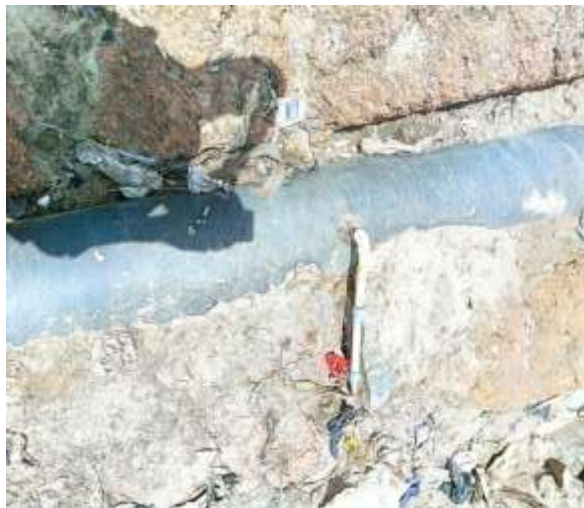
extensively perforated to meet the water demands of the newly emerging neighborhoods (see Plate 1). This extensive drilling has resulted in increased leakage and a significant reduction in the pressure with which water can move within the pipe. The numerous perforations in the high-pressure pipeline have caused severe adverse effects on the water distribution system.

Notably, water from the Erelu waterworks no longer reaches the booster station on Sooro Hill, where

Plate 1: 12 Inches High Lift Pipe Connected Directly by household.
