# Shaft Voltage and Current Phenomena in Turbo generators: Case Study of Post-Overhauling Bearing Anomaly at a 210 MW KWU Turbine Set

<sup>1,2</sup>Sr. Manager, BHEL, Bharat Heavy Electricals Limited, Varanasi, India

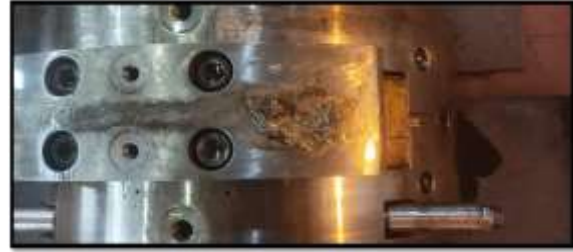
Figure 3: Electrical discharge markings at bearing torus support.

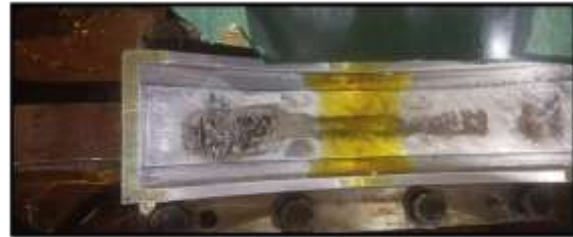
Figure 4: Bearing support showing discharge-induced wear.

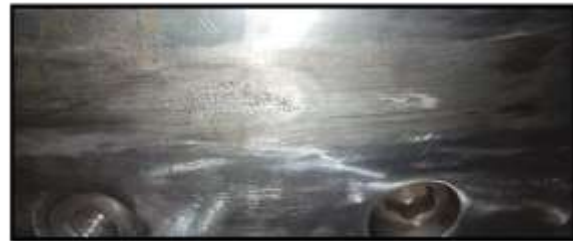
Figure 5: Bearing surface discoloration consistent with overheating and arcing.

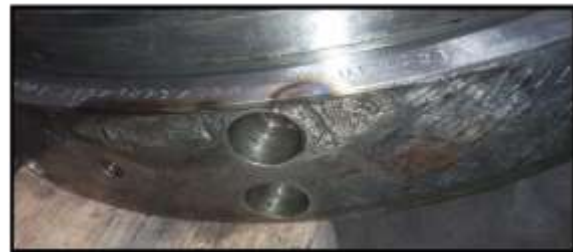
Figure 6: Discharge evidence at torus contact surface.

The major cause of damage was improper grounding that prevented the discharging through low resistance path and in turn forced the same to be mitigated through bearings causing electrical discharge, initiating EDM pitting/frosting and localized film breakdown/heat. The resulting stiction and micro-rubs increase vibration, further modulating air-gap asymmetry and promoting additional charging—a self-reinforcing loop creating a restriction in bearing free movement that resulted in heavy vibrations, these acted as a complement to rubbing caused in LP further fueling electrostatic charge and spiraling the effect to create the damage.

- Bearings 4 and 5 were replaced with new bearing, followed by precision blue matching, centering and resetting of all assembly clearances as per norm.
- Labyrinth seals were re-machined to remove rubbing marks and restore clearances.
- Grounding brushes were replaced and their contact surfaces cleaned to ensure low-resistance paths.
- Electrical insulation and resistance-to-ground checks were performed to confirm integrity of the grounding system.
- LP roll checks were done and re set values with proper offsets.

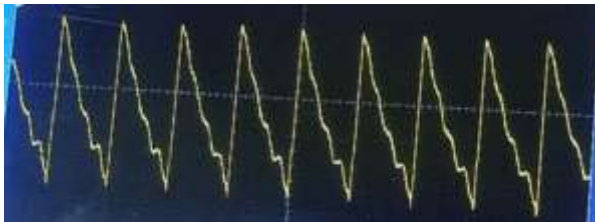
Spectral discrimination. To isolate the excitation system as a source, the exciter and shaft-voltage waveforms were compared. The exciter showed a pulsating DC component at 300 Hz (6-pulse rectifier ripple), whereas the shaft-voltage spectrum lacked a coherent 300 Hz line, indicating that static-exciter ripple was not the dominant contributor under these conditions. With stator loading, a low-amplitude, slowly varying AC influence on the shaft voltage was detectable, but its magnitude remained small relative to the 50/100 Hz induction signature and impulsive events.

Figure 9: Pulsating Excitation Voltage 300 Hz

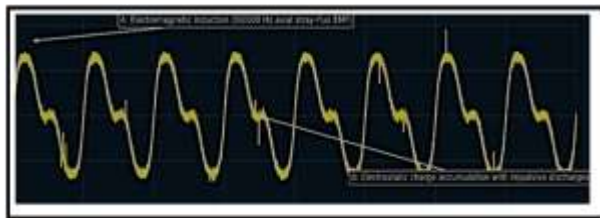
Figure 10: Developed voltage waveform

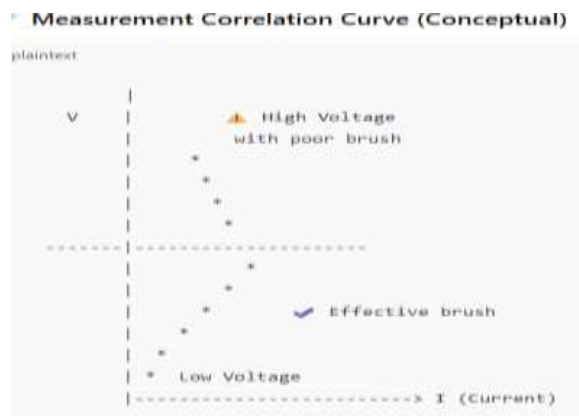
Grounding Brush Condition	Shaft Voltage (V)	Shaft Current (A)	Interpretation
Excellent	~1-5V	High (~.1-2.5 A)	Good discharge path
Worn or Dirty	~6-20 V	Low (<.05 A)	Current blocked, voltage builds up
Broken/Absent	>20 V	~0 A or erratic	Dangerous — voltage rising, no discharge

- A clean brush has low contact resistance → shaft voltage gets clamped close to earth potential.
- A dirty or worn brush has high contact resistance → less current can flow → shaft voltage increases due to charge accumulation.

Figure 10: V~I relationship w.r.t grounding behavior
