# Data-Driven Condition Assessment and Remaining Life Prediction of Low-Voltage Distribution Transformers Using Insulation Resistance Measurements: A Case Study of Ajayi Crowther University Distribution Network

**Abstract-** This paper presents a comprehensive insulation resistance (IR) assessment of low voltage distribution transformers at Ajayi Crowther University (ACU), Oyo, Nigeria. The study evaluates the safety, reliability, and operational efficiency of four distribution transformers (three 500 kVA units and one 750 kVA unit) through systematic IR testing using a Megger MIT1025 insulation tester. Testing was conducted in three configurations: Line-to-Earth (L-E), Neutral-to-Earth (N-E), and Line-to-Neutral (L-N), with results corrected to a standard temperature of 20°C and benchmarked against IEEE standards. Statistical analysis revealed an overall mean corrected IR of 137.5 MΩ with a standard deviation of 21.46 MΩ. Three transformers (T1, T3, and T4) demonstrated healthy insulation with corrected IR values ranging from 100 to 160 MΩ. However, transformer T2 exhibited localized insulation degradation, failing the L-N test with a corrected IR of 90 MΩ, below the IEEE minimum

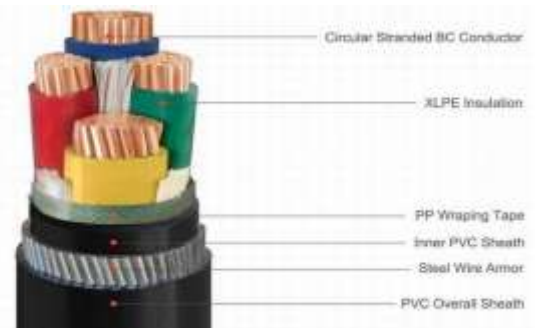
Fig. 2. Cross-section of a multi-core XLPE-insulated armored cable showing insulation layers: BC

Conductor, XLPE Insulation, PP Wrapping Tape, Inner PVC Sheath, Steel Wire Armor, and PVC Overall Sheath.

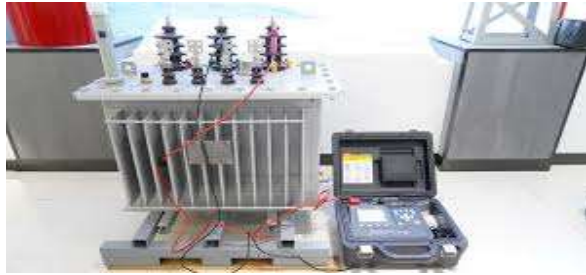
Fig. 4. Distribution transformer under test connected to the Megger MIT1025 insulation resistance tester.

Insulation resistance measurements were performed using the Megger MIT1025 digital insulation tester, a precision instrument capable of applying DC test voltages from 50V to 10kV and measuring insulation resistance from 0.01 MΩ to 35 TΩ. The instrument

provides automatic temperature compensation and data logging capabilities. A test voltage of 1000V DC was applied for all measurements in accordance with IEEE C57.12.90 guidelines for low-voltage distribution transformers rated at 415V.

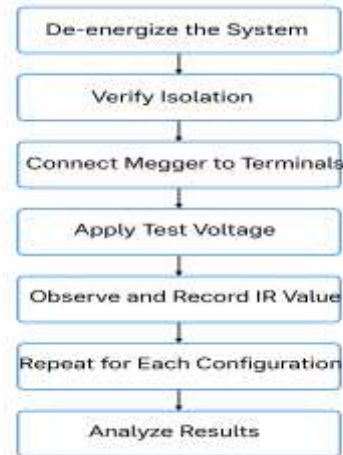
Fig. 6. Testing procedure flowchart

The testing procedure followed a systematic sequence to ensure accuracy, repeatability, and personnel safety. Each measurement was held for 60 seconds at the applied test voltage before recording the stabilised resistance value.

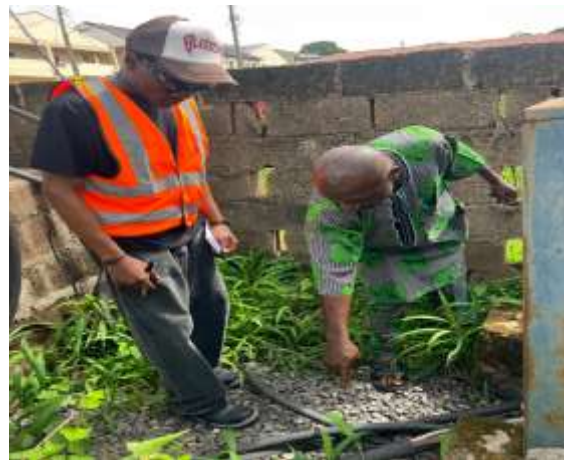
Fig. 7. Field engineers conducting insulation resistance measurements on the distribution network at ACU. The researcher (right, in orange safety vest) records readings while the technician manages test connections.

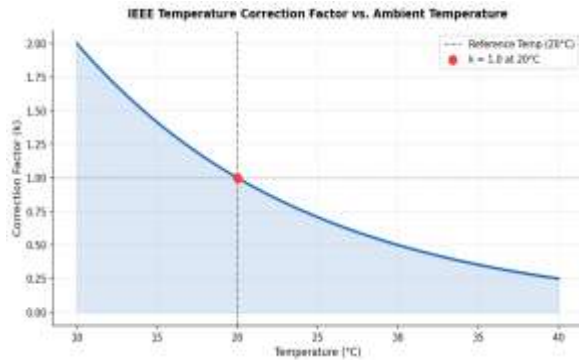
Fig. 8. IEEE temperature correction factor ( $k$ ) as a function of ambient temperature. All measured IR values were multiplied by  $k$  to obtain the standardised 20°C reference values.

Since insulation resistance varies significantly with temperature, all measured values were corrected to the standard reference temperature of 20°C using the IEEE correction formula:

$$IR_{20} = IR_{measured} \times k$$

where  $IR_{20}$  is the corrected insulation resistance at 20°C,  $IR_{measured}$  is the value recorded at the ambient test temperature, and  $k$  is the temperature correction factor. The correction factor  $k$  follows the relationship  $k = 0.5^{((T - 20)/10)}$ , where  $T$  is the ambient temperature in °C at the time of testing [8], [21].

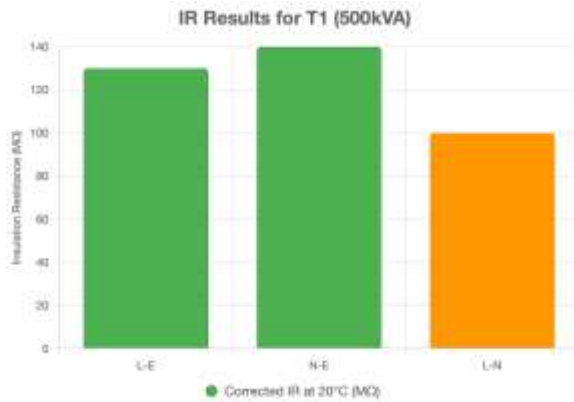
T1 recorded corrected IR values of 130 MΩ (L-E), 140 MΩ (N-E), and 100 MΩ (L-N). All three values meet or exceed the IEEE minimum threshold of 100 MΩ, indicating satisfactory insulation condition. The relatively lower L-N value (100 MΩ) suggests minor inter-winding insulation stress, which should be monitored in future testing cycles.

Fig. 9. IR test results for T1 (500 kVA) L-E: 130 MΩ, N-E: 140 MΩ, L-N: 100 MΩ. All values meet the IEEE 100 MΩ minimum threshold (PASS).

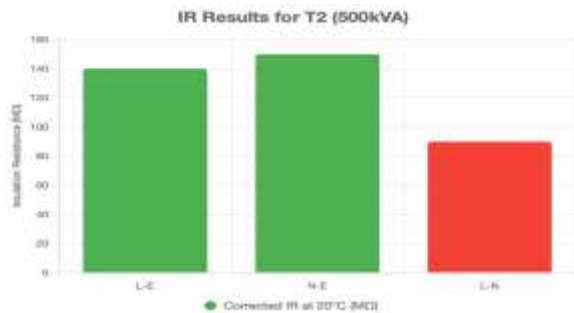
4.3.2 Transformer T2 (500 kVA) Critical Finding  
 T2 is the only transformer that failed IEEE compliance. While the L-E (140 MΩ) and N-E (150 MΩ) configurations passed comfortably, the L-N configuration recorded a corrected IR of 90 MΩ 10% below the IEEE minimum of 100 MΩ. This localised degradation in the inter-winding insulation is consistent with moisture ingress or partial discharge activity between the phase and neutral windings [14], [15]. Immediate corrective action is recommended.

Fig. 10. IR test results for T2 (500 kVA) the L-N configuration (red bar, 90 MΩ) falls below the IEEE 100 MΩ minimum threshold, indicating localized insulation degradation (FAIL).

The failure of T2's L-N configuration is the most significant finding of this study. The 90 MΩ reading, while only 10% below the threshold, represents a critical warning sign. Research by Robalino et al. [19] and Mustafa et al. [30] has demonstrated that transformers exhibiting inter-winding insulation values approaching the minimum threshold are at elevated risk of dielectric breakdown under transient overvoltage conditions. The localized nature of the degradation (L-N only, while L-E and N-E remain healthy) suggests moisture ingress or partial discharge activity in the inter-winding space rather than a systemic insulation failure [29], [30].

- i. Immediate (T2): Conduct detailed diagnostic investigation including dissolved gas analysis (DGA), Tan delta measurement, and visual inspection of T2's inter-winding insulation. Consider oil purification or drying treatment.
- ii. Short-term (6 months): Repeat IR testing on all four transformers to track insulation trends, particularly monitoring T1's L-N values for signs of continued aging.
- iii. Long-term: Implement a formal annual preventive maintenance programme incorporating IR testing, oil sampling, and thermal imaging for all distribution transformers.
- iv. Infrastructure: Install permanent moisture monitoring sensors and ensure transformer enclosures are adequately sealed against environmental ingress.

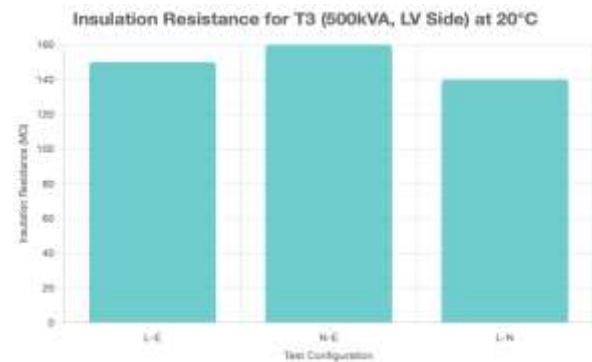
T3 demonstrated the best performance among the 500 kVA units, with corrected IR values of 150 MΩ (L-E), 160 MΩ (N-E), and 140 MΩ (L-N). All values significantly exceed the IEEE minimum, indicating excellent insulation condition. The high and consistent values across all configurations reflect

well-maintained insulation with no signs of moisture or thermal degradation.

Fig. 11. IR test results for T3 (500 kVA, LV Side) at 20°C L-E: 150 MΩ, N-E: 160 MΩ, L-N: 140 MΩ. All values significantly exceed the IEEE standard (PASS).

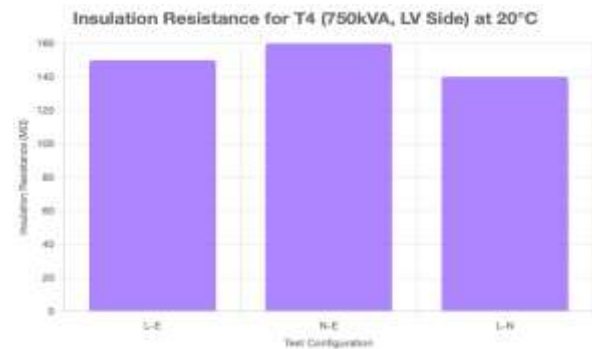
T4, the highest-rated transformer on campus at 750 kVA, recorded corrected IR values of 150 MΩ (L-E), 160 MΩ (N-E), and 140 MΩ (L-N). These values are identical to T3 and indicate excellent insulation health. Despite being the most heavily loaded unit, T4's insulation condition is commendable and reflects good design and maintenance practices.

Fig. 12. IR test results for T4 (750 kVA, LV Side) at 20°C L-E: 150 MΩ, N-E: 160 MΩ, L-N: 140 MΩ. All values significantly exceed the IEEE standard (PASS).

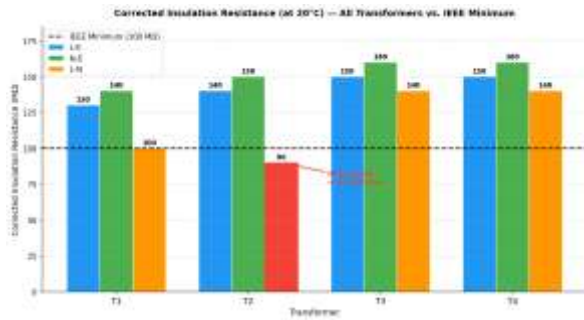
Figure 13 presents a consolidated grouped bar chart comparing the corrected IR values for all four transformers across all three test configurations, with the IEEE 100 MΩ minimum threshold shown as a dashed reference line. The chart clearly illustrates

T2's L-N failure and the consistently superior performance of T3 and T4.

Fig. 13. Grouped bar chart of corrected IR values (at 20°C) for all four transformers across L-E, N-E, and L-N configurations. The dashed line marks the IEEE 100 MΩ minimum. T2 L-N (red bar) is the only measurement below the threshold.

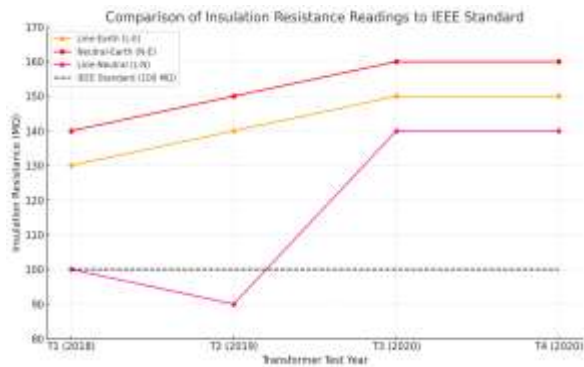
Fig. 14. Line chart comparing insulation resistance readings across all test configurations against the IEEE 100 MΩ standard, clearly showing the T2 L-N dip below the threshold.

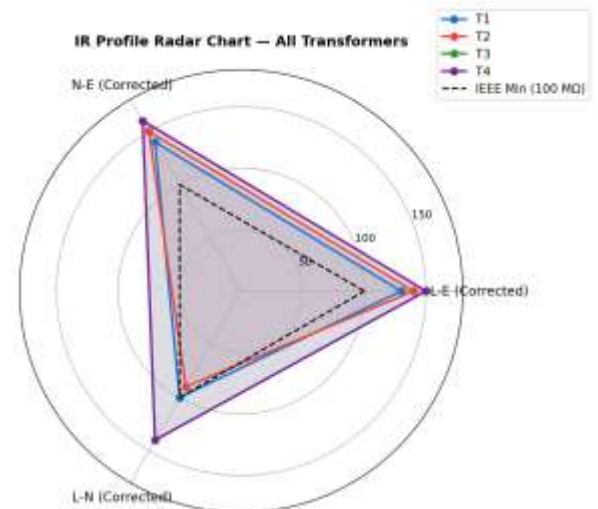
The radar chart in Figure 16 provides a holistic visualisation of each transformer's IR performance profile across all three test configurations simultaneously. T3 and T4 exhibit near-identical, well-balanced profiles with high values on all axes. T1 shows a slight contraction on the L-N axis, while T2 shows a pronounced dip in the L-N axis, graphically confirming the localised inter-winding insulation weakness.

Fig. 16. Radar chart showing the IR performance profile of each transformer across all three test configurations. T2 shows a pronounced dip in the L-N axis, indicating localised insulation degradation.

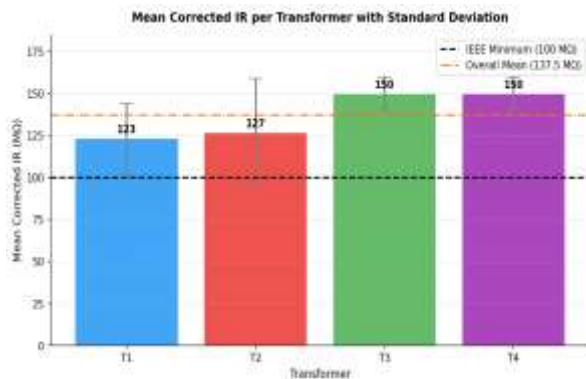
The overall mean corrected IR of 137.5 MΩ is 37.5% above the IEEE minimum threshold, reflecting generally healthy insulation across the distribution network. However, the relatively high standard deviation in the L-N configuration (23.63 MΩ) compared to L-E (9.57 MΩ) and N-E (9.57 MΩ) is attributable to T2's anomalously low L-N value, indicating that inter-winding insulation is the most variable and vulnerable aspect of the system.

Fig. 17. Mean corrected IR per transformer with  $\pm 1$  standard deviation error bars. The orange dash-dot line represents the overall system mean (137.5 MΩ); the dashed line is the IEEE minimum (100 MΩ).
