Determination of Pavement Condition Index and Maintenance Cost Evaluation At The federal Polytechnic Nasarawa, Nigeria

MUHAMMAD SANI ALIYU[1], ABDULKADIR SABO OSU[2], ALIYU MUHAMMAD AMINU[3], HAMZA HAMZA MUSA[4], USMAN HASSAN AHMAD[5]
[1, 2, 3, 4, 5] *Department of Civil Engineering Technology, Federal Polytechnic Nasarawa, Nigeria*

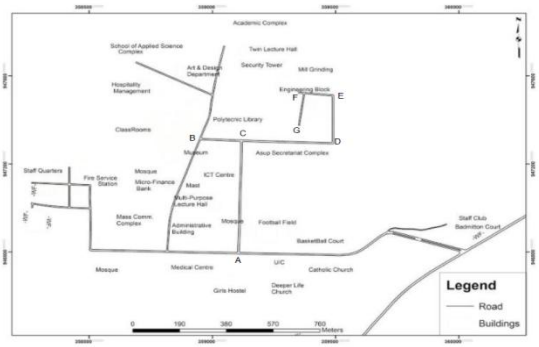
Figure 3.2 FPN Road Network, Branch and Section being Surveyed

The network comprises of the entire paved roadway within the Federal Polytechnic Nasarawa, Nigeria. This road networkburtsoutto the North-South highway (that runs through Loko-Uwetu bridge).Nasarawa city is about 70km from Nigeria's capital, Abuja. Branch ABCDEF of the road was chosen for this study due to the fact that it is in worse condition than the other branches, which have recently been rehabilitated. Section BCD has equally been selected as a representative sample after the Inventory Survey because it had clear distresses than the others. See the figure below:

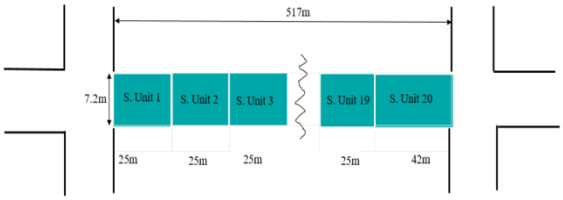
Figure 3.3 Total Sample Units in Section BCD

Taking N, Total number of sample units in the section = 20

Length of a sample unit = $\frac{517}{20}$ = 25.85m

By Rearranging: $[(25m\times 19) + 42 \times 1]$

25× 7.2 = 180m2>150m2, OK (see Table 3.1 above)
42× 7.2 = 302.4m2<350m2, OK (see Table 3.1 above)
